Aeration & Bacterial Dosing Case Study: Transpacific

Transpacific is Australia's leading recycling, industrial services and waste management provider. They service clients from in excess of 300 sites and depots and have over 40 major processing plants across Australasia.

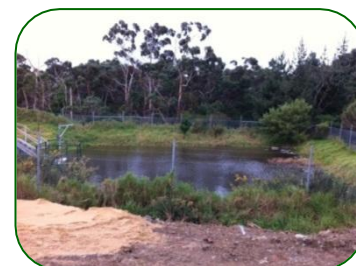
Initial independent tests showed that this particular Transpacific green waste pond had high levels of sludge, low dissolved oxygen levels and high contaminant levels. This was delaying and impeding the degradation of the waste, as well as causing foul odours to emit from the pond.

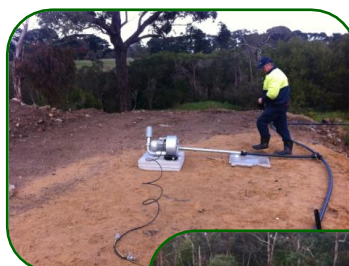
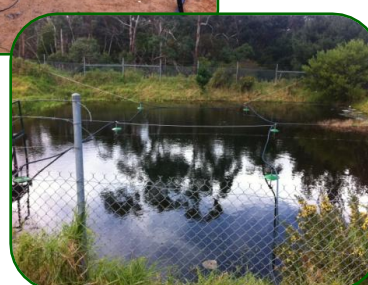
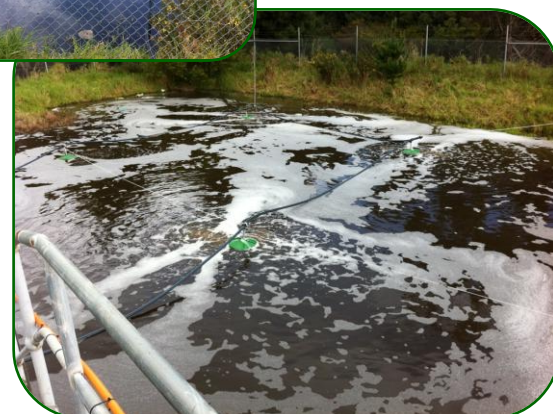
These 3 pictures show the aeration system being installed, and then in working order.

Firstly, a custom aeration system was installed in the pond. This aeration system was designed to increase the dissolved oxygen levels within the pond and stir up the sludge from the bottom of the pond so that the solids could be broken down more effectively. This, in turn, would encourage and expedite the natural degradation process of the waste material.

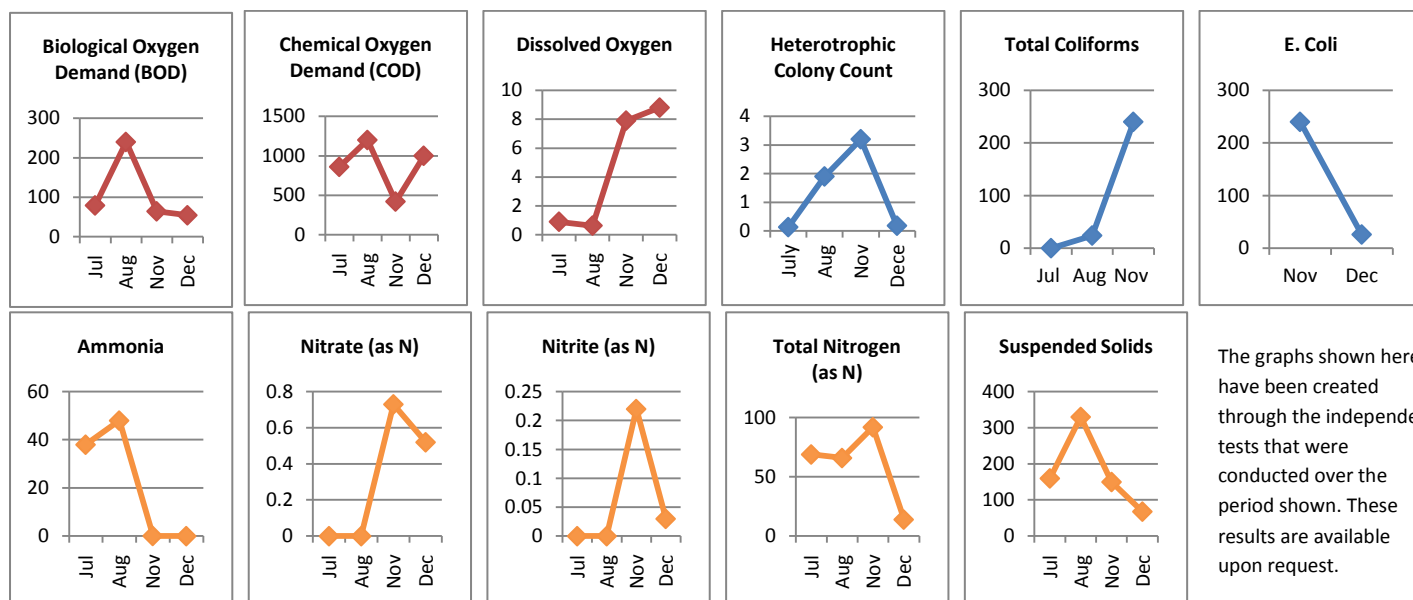
After dosing with Ecogreen Pond Maintainer for just 1 month, tests showed that the solids had reduced enormously and the sludge that had previously been resting on the bottom of the pond had cleared. Furthermore, the Ammonia levels had decreased considerably, as had the Nitrogen levels. Although the presence of E.coli was only examined in the final 2 tests, a drastic decline was visible after just 1 month.

The graphs shown here have been created through the independent tests that were conducted over the period shown. These results are available upon request.

Following the installation of the aeration system, we analysed two separate samples over a two month period. These results showed that the dissolved oxygen had increased by approximately 8 times.

In turn, the suspended solids had also increased drastically over the initial period as the sludge was stirred throughout the pond. This then began to reduce as the natural degradation process took effect. Throughout this period there were significant changes; the total bacteria levels within the pond had risen significantly, as had the nitrate and TKN etc. The level of ammonia also rose slightly initially. This was all due to the aeration releasing all the contaminants trapped within the sludge itself.
